Technical Note N- 1113

THE SPHERICAL ACRYLIC PRESSURE HULL FOR  
HYDROSPACE APPLICATION; PART II - EXPERIMENTAL  
STRESS EVALUATION OF PROTOTYPE NEMO CAPSULE

J. D. Stachiw and K. L. Mack

October 1970

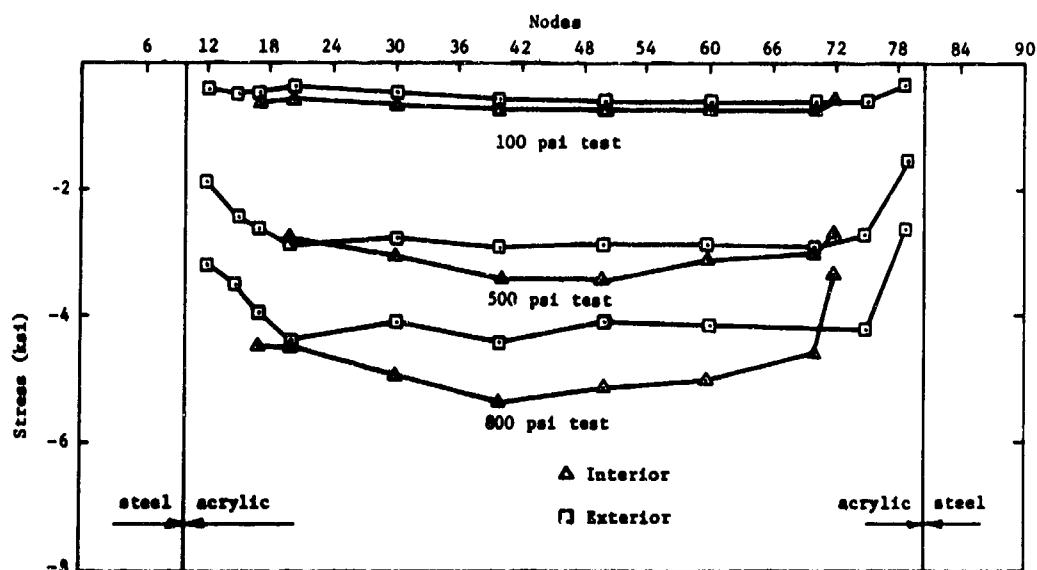
Acrylic Plastic. The stresses measured on the acrylic plastic hull (Figures 15 and 19) varied from one strain gage rosette to another depending on their location. For all rosettes on the acrylic plastic stresses were higher on the interior of the hull. At the equator of the hull maximum and minimum principal stresses in the plane of the hull's surface were approximately the same. As one progressed, however, from the equatorial rosettes to those located near the polar penetrations in the hull, the difference between maximum and minimum principal stresses in the plane of the hull's surface increased. At the edge of the penetration the highest principal stress was in the meridional direction and its magnitude on the exterior of the hull was approximately the same as the maximum principal stress at the equator, while the least principal stress was in the hoop direction and its magnitude was approximately 45 percent less.

The relationship between the hydrostatic pressure and stresses on the acrylic was linear and approximately the same for the short-term portions of all Phase I tests. This indicates that no yielding of the acrylic occurred under short-term loading at any of the locations where the strain gage rosettes were located even when the NEMO hull was hydrostatically loaded to 800 psi (Figure 19). At 500 psi the maximum principal stress recorded on the external surface in equatorial region was -3008 psi while on the interior it was -3423 psi. No higher stresses than 3423 psi were recorded at any other rosette location on the acrylic hull at 500 psi loading.

Figure 15a. Distribution of Hoop Stresses on the NEMO acrylic hull.

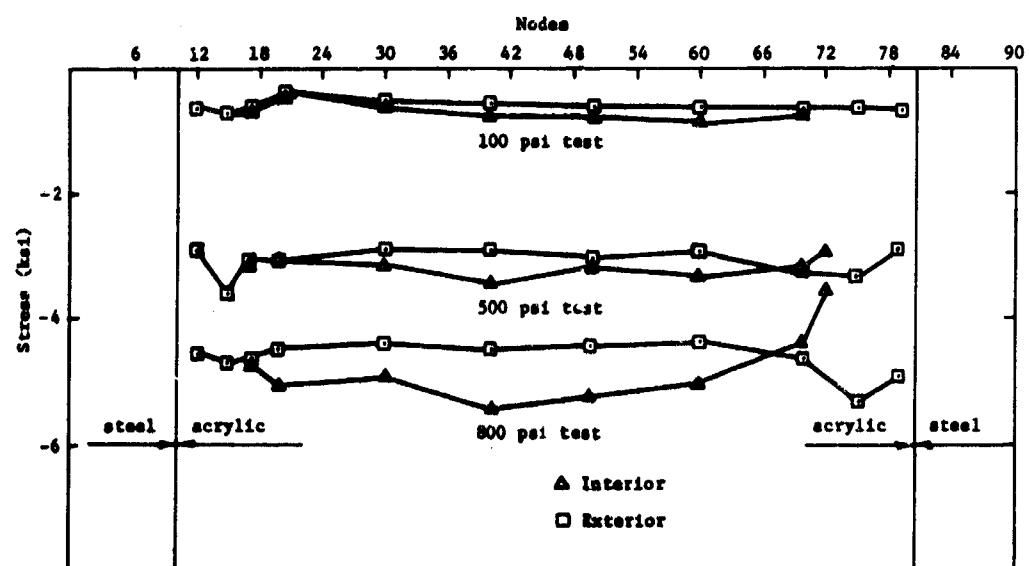
Figure 15b. Distribution of Meridional Stresses on the NEMO acrylic hull.

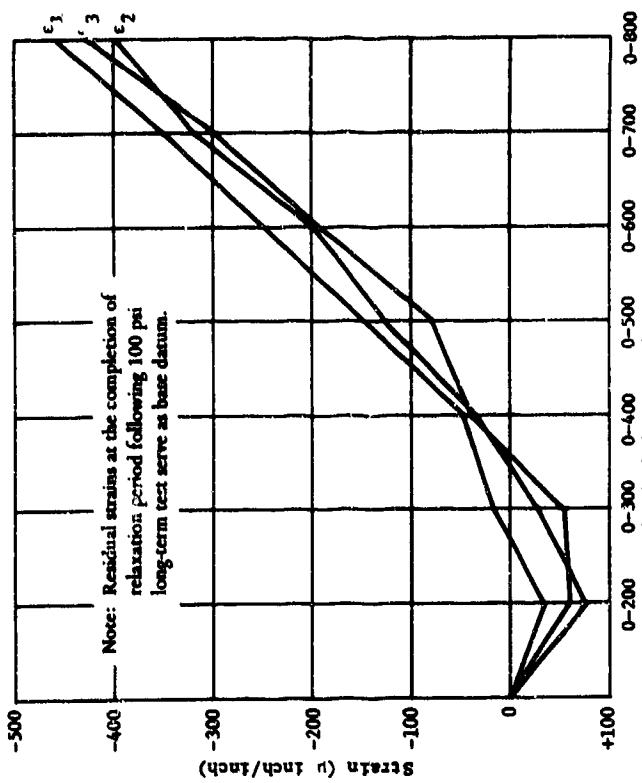
Factor A is the change in relative position between the steel plate and the penetration in acrylic. During pressurization, the plate is forced deeper into the opening. Upon depressurization the surface friction between steel and acrylic does not often permit the steel plate to return to its original location in the opening. Because of this, the steel remains under compressive preload whose magnitude increases from test to test by approximately 100 microinches. Since in the calculation of stresses the strain reading at the beginning of each test is taken as the zero datum the determination of residual stresses after each test was not accomplished by comparing stresses from different tests but by comparing the magnitude of residual strains after completion of relaxation periods at the end of all Phase I tests (Figures 21 and 22) with the magnitude of residual strain at the completion of relaxation period following the long-term loading at 100 psi.

Figure 21c. Residual strains on the exterior of the acrylic hull at the polar penetration at the conclusion of each long-term test; Rosette 18A.

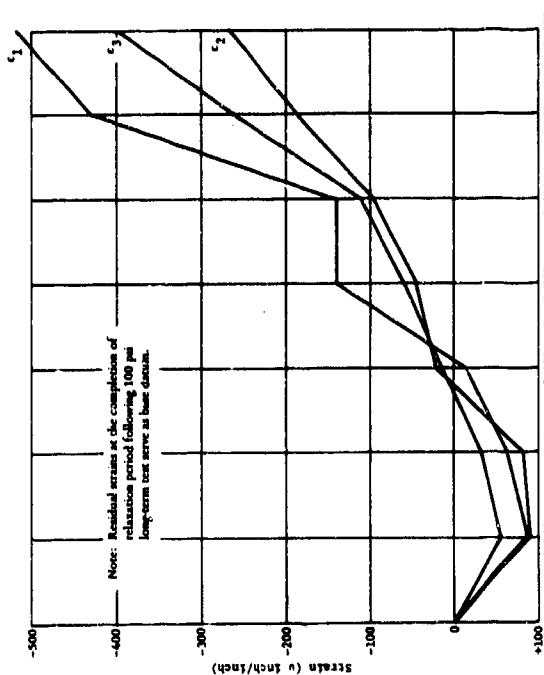
Figure 21a. Residual strains on the exterior of the hull in the equatorial region at the conclusion of each long-term test; Rosette 12A

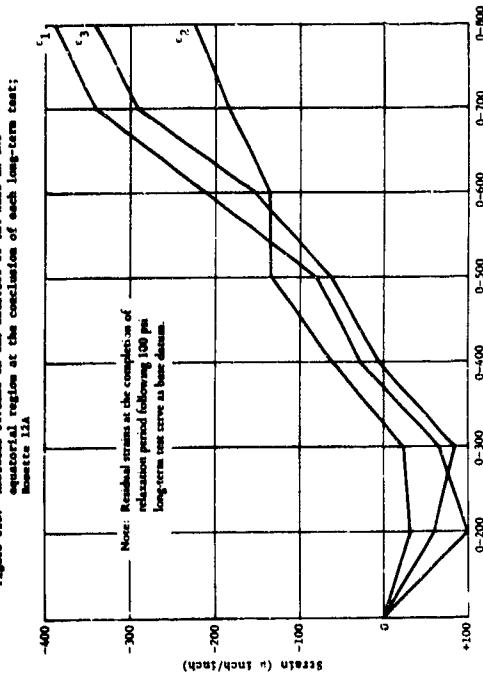
Figure 21b. Residual strains on the exterior of the hull in equatorial region at the conclusion of each long-term test; Rosette 12B.

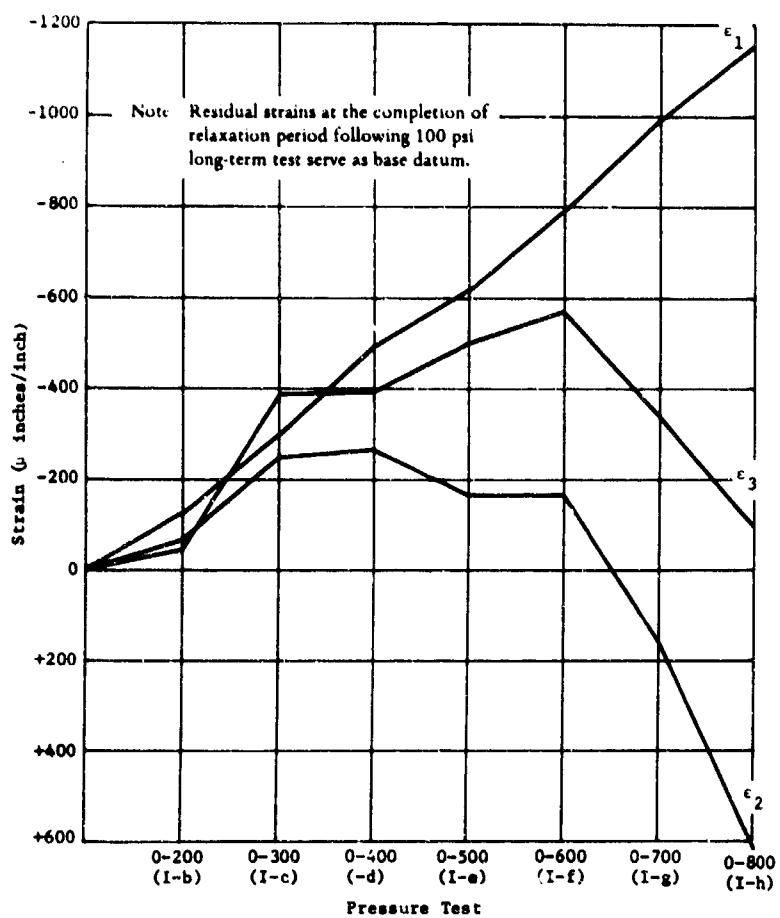
Figure 22a. Residual strains on the interior of bottom steel plate at the conclusion of each long-term test; Rosette 3A.

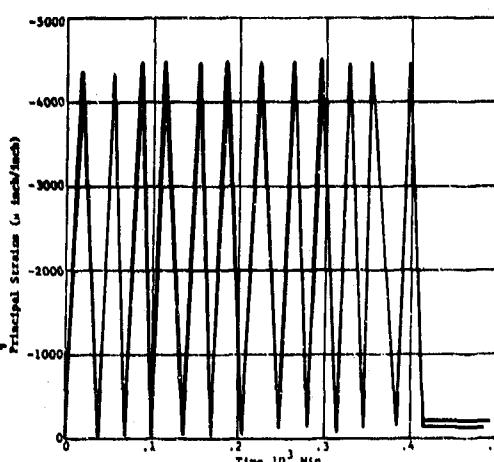
Figure 3lb. Cyclic strains on the interior surface of the acrylic hull in equatorial region; Rosette 10B under pressure cycles of 500 psi magnitude and 2-minute duration.

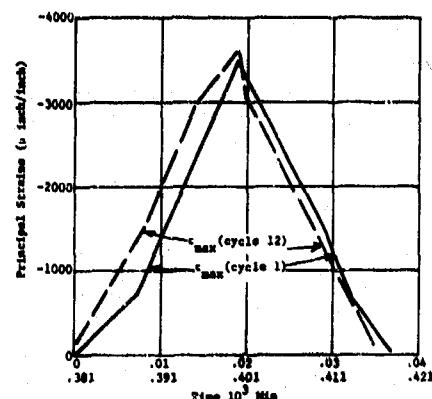
Figure 3lc. Comparison of maximum and minimum strains for cycles 1 and 12 on the exterior surface of the acrylic hull in equatorial region; Rosette 10A under pressure cycles of 500 psi magnitude and 2-minute duration.

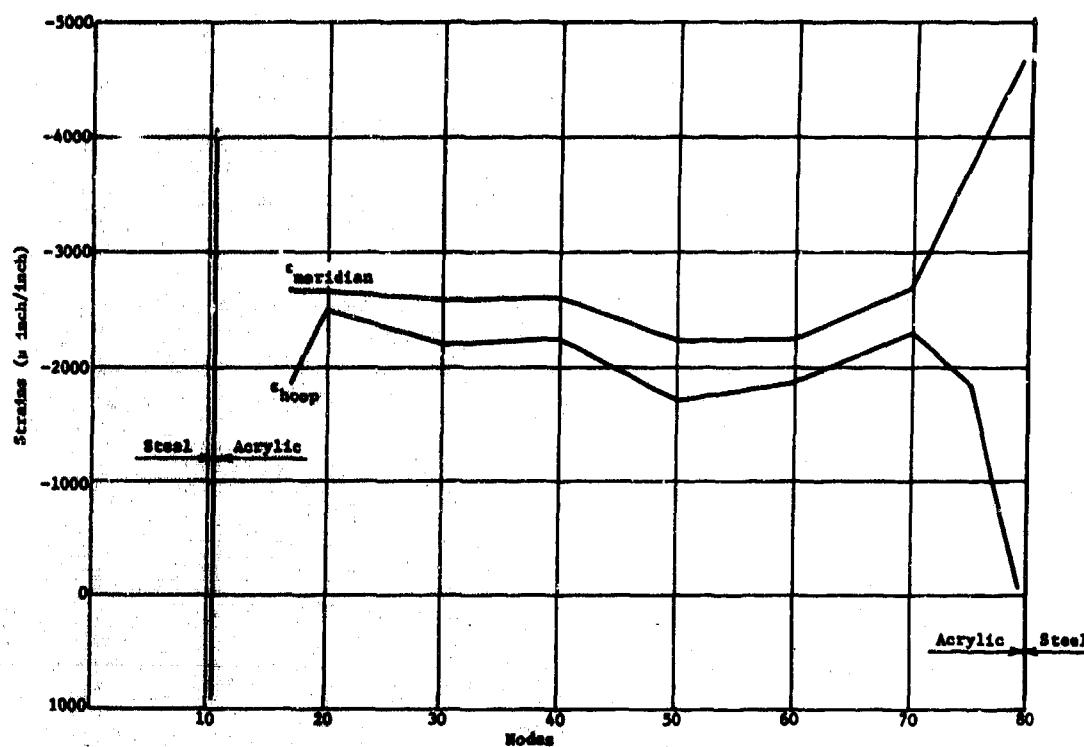
Figure 32a. Distribution of hoop and meridional strains on the exterior surface of acrylic hull at the midpoint of the second 2-minute pressure cycle at 500 psi.

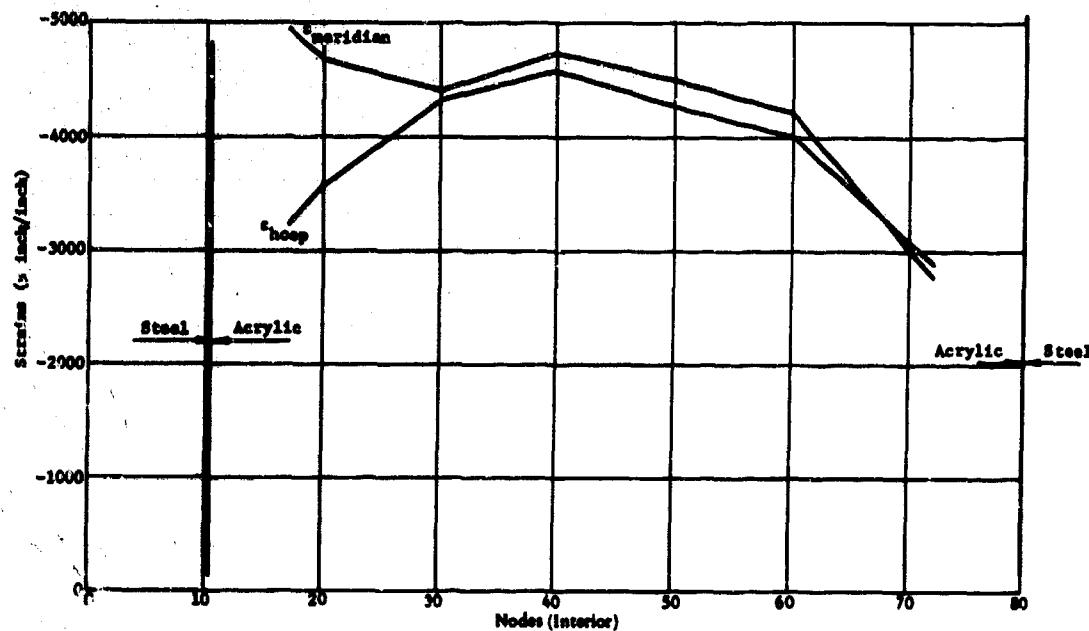
Figure 32b. Distribution of hoop and meridional strains on the interior surface of acrylic hull at the midpoint of the second 2-minute pressure cycle at 500 psi.

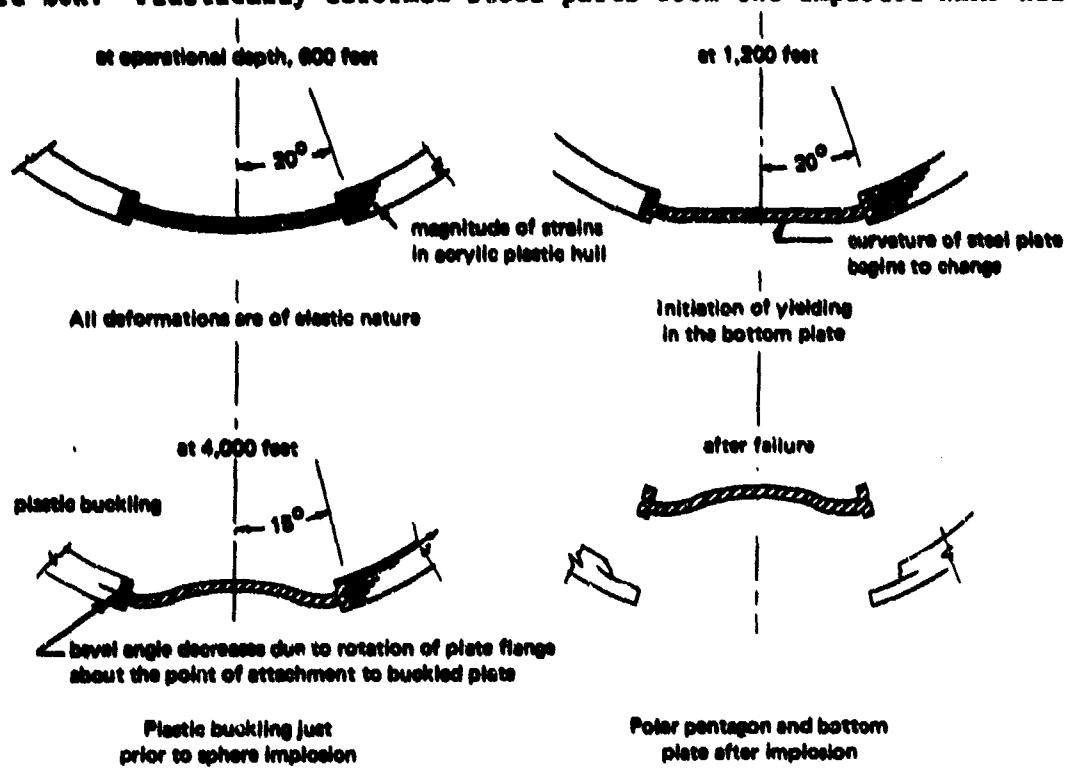
Figure 36b. Mechanism of spalling in the bottom polar acrylic pentagon reconstructed from observation of deformation in the bottom steel plate and fracture in the bottom polar acrylic pentagon.
